Z-LYFTEN PRODUKTION AB

Service Message

2019-01-17

Regarding: Solenoids

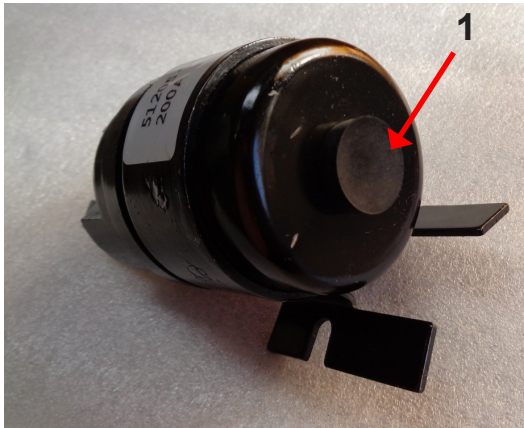
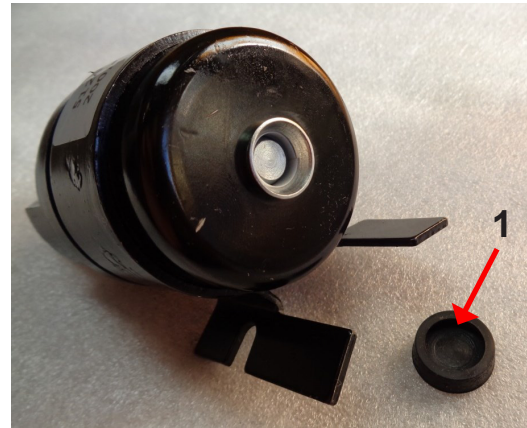
Replace solenoids with lost sealing.

If the rubber seal (1) on the solenoid is gone, the inside of the solenoid is unprotected and it is exposed to moisture and dirt. This leads to rust and an unreliable function. Among other things, the magnetic strength inside the solenoid becomes too weak (one can hear a chattering sound) and the solenoid eventually cannot handle to start the electric motor.

If the rubber seal is gone, we recommend you to replace the solenoid to prevent downtime.
